# TEST REPORT

Report No. : BJ-R230523105A-03-EN

Test Item : IP69K Test

Sample Name	Smartphone
Sample Model	KINGKONG POWER
Trade Name	CUBOT
Sample No.	BJ-R230523105A-5#~6#
Sample Size	/
Weight Of Sample	/
Sample Quantity	2 PCS
Manufacturer	Shenzhen Huafurui Technology Co., Ltd.
Address	Unit 1401 &1402, 14/F, Jinqi Zhigu Mansion (No. 4 Building of Chongwen Garden), Crossing of the Liuxian Street and Tangling Road, Taoyuan Street, Nanshan District, Shenzhen,P.R. China
Sample Source	Commissioned units send sample
Inspection Type	Commissioning test
Sample Description	Sample appearance is good

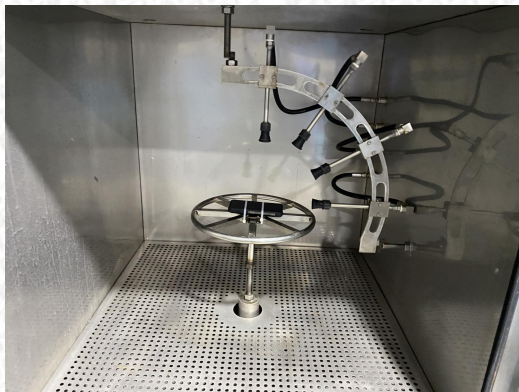
IPX9K: 6#

Water temperature	80±5℃
pressure	(8000~10000) kPa
Water flow	14~16L/min
distance	10~15cm
Angle and time	0°、30°、60°、90° 30 seconds per angle

Test setup

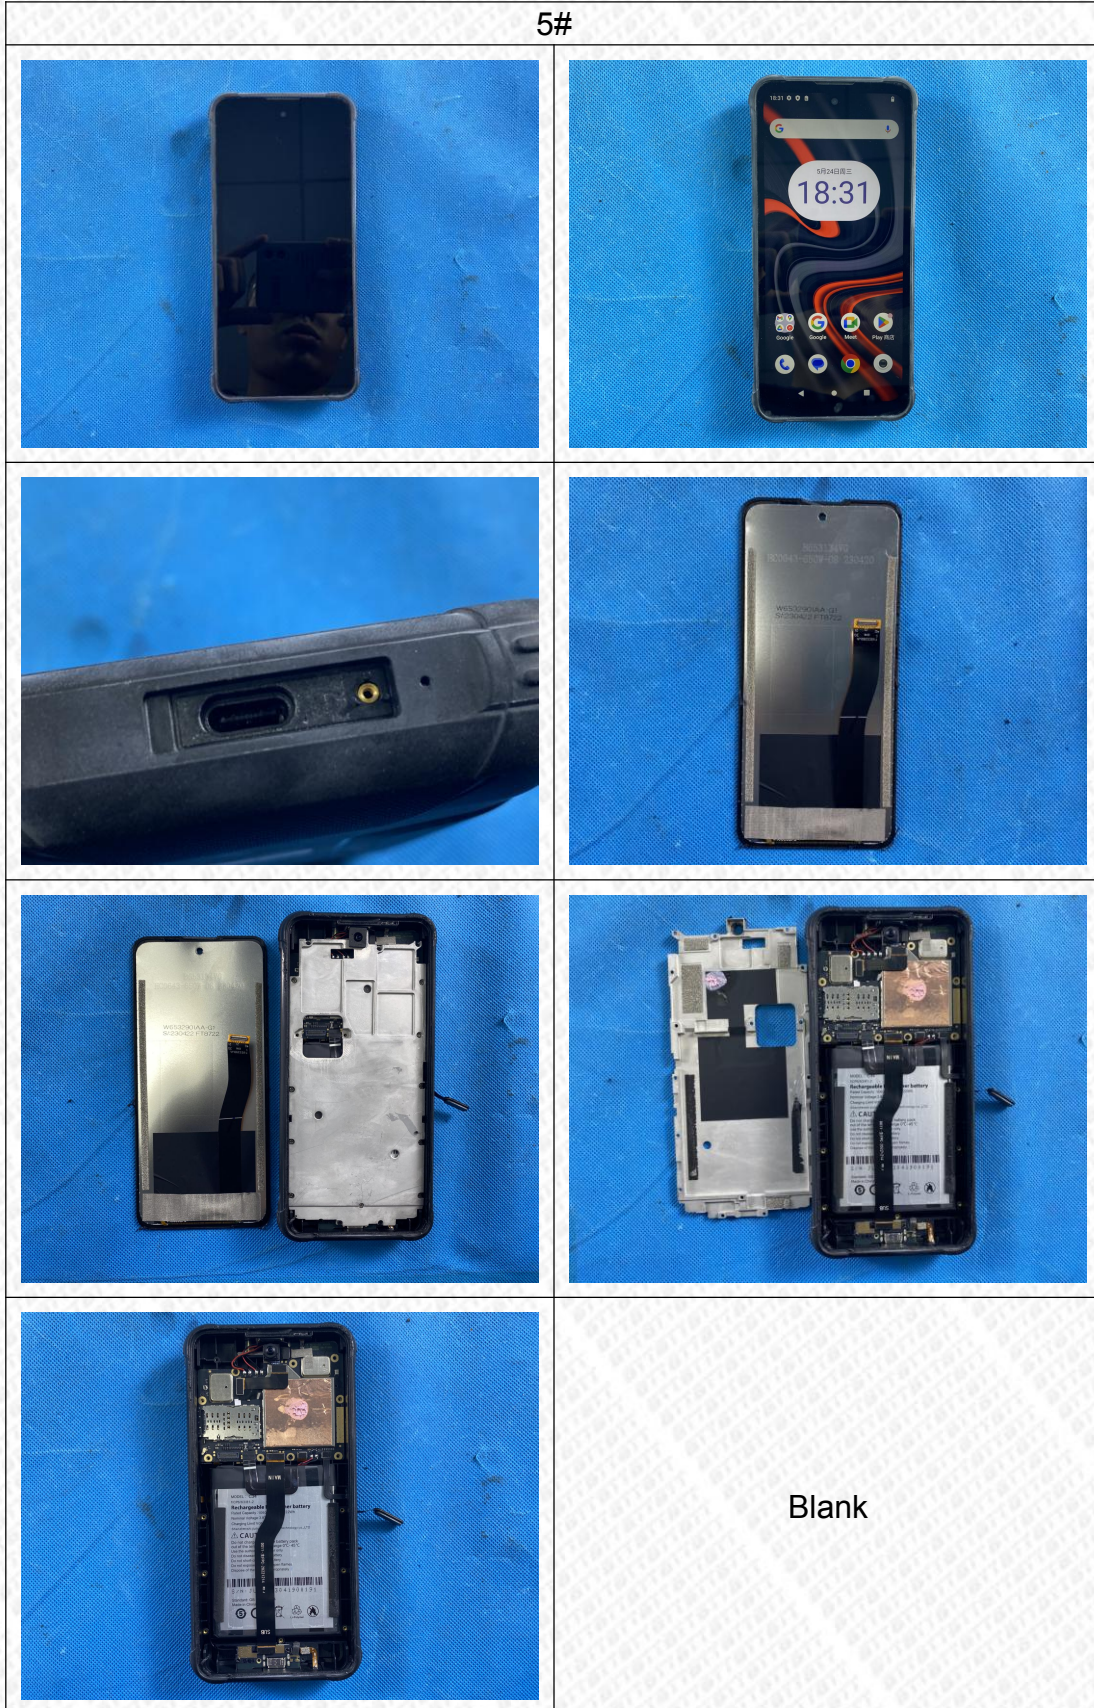
Test Items	Sample No.	Test Results
IP6KX Test	5#	After test, there was no dust enter the enclosure of sample and the function was normal.
IPX9K Test	6#	After test, there was no water enter the enclosure of sample.

After test--IP6KX

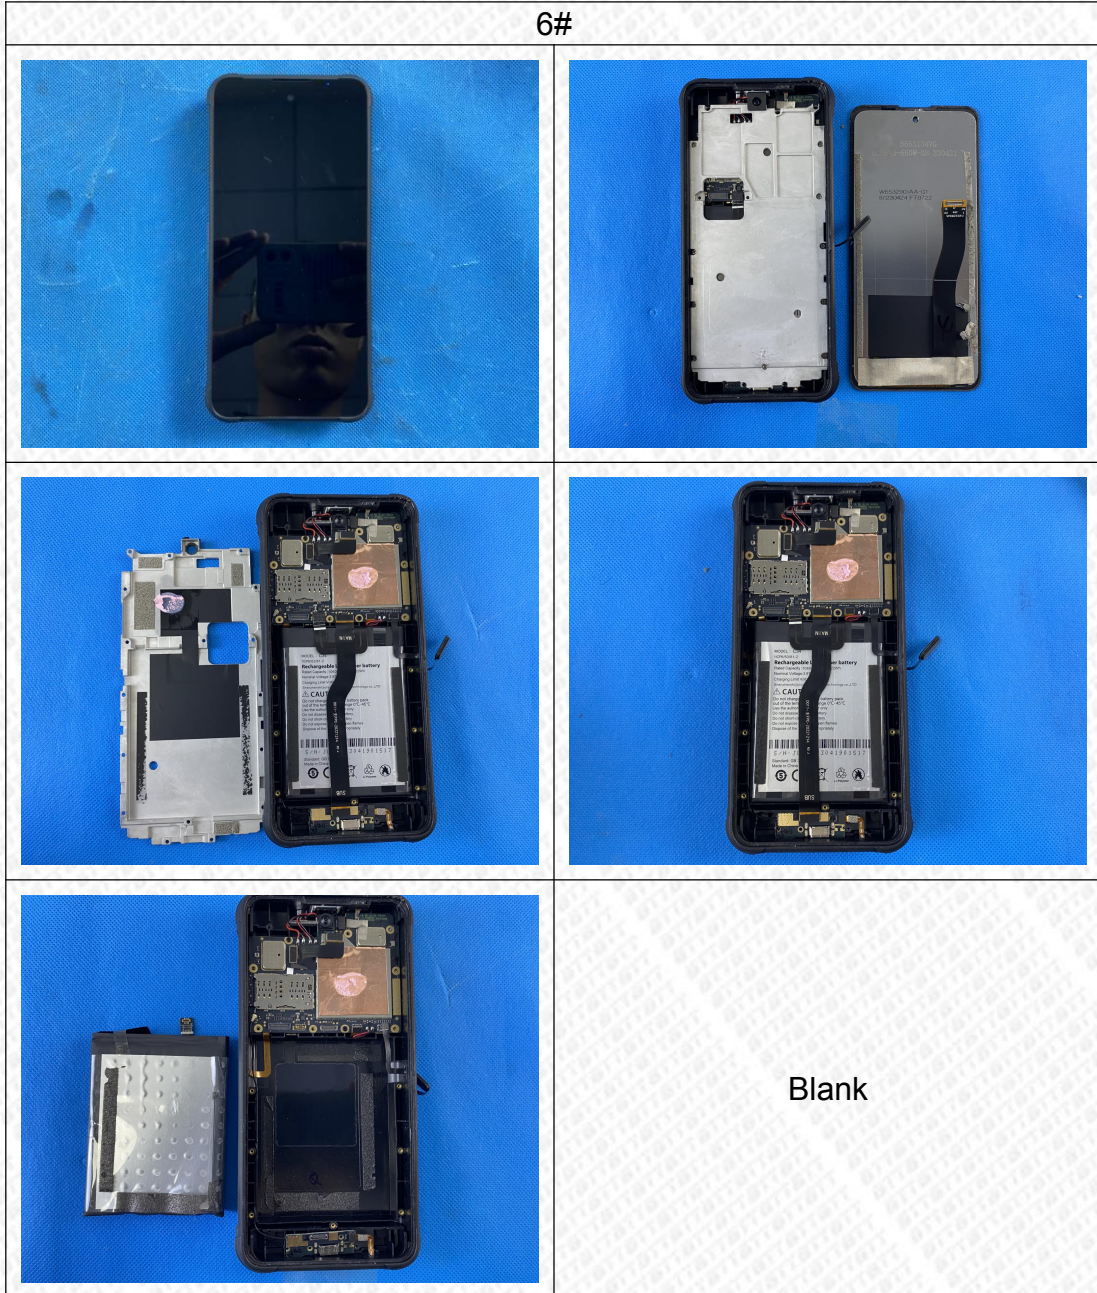
6#

After test--IPX9K
